## Fastener Corrosion: A Ticking Time Bomb?

by Skip Walker

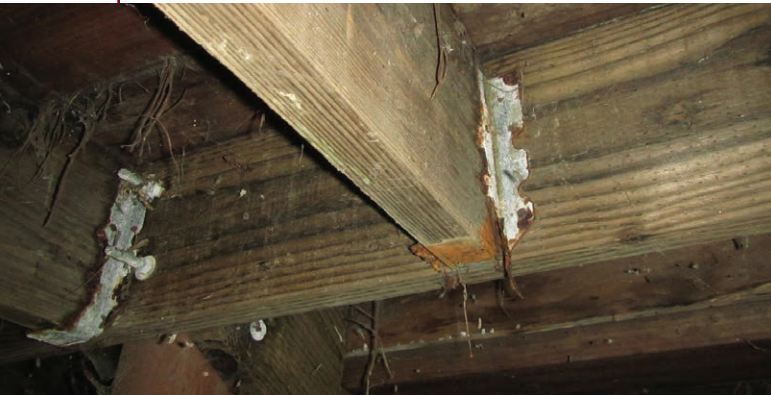
Located a few miles inland from the coast in California, this deck was built in 2006 using lumber treated with copper azole (CA) to retention levels for above-ground use (UC3B). Note the severe corrosion of the 10-year-old joist hangers.
